# Support Center Bulletin

Subject: Subject: Echelon Troubleshooting Guide

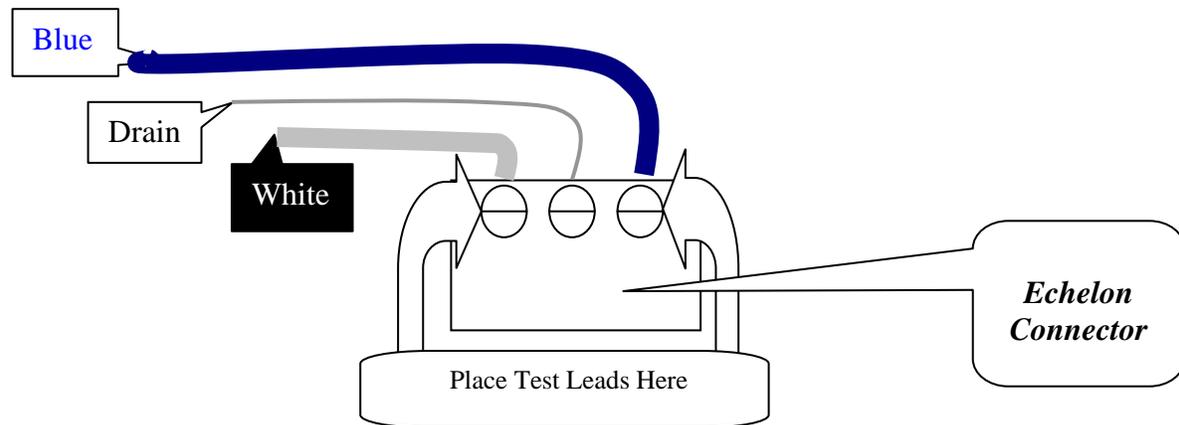
Step One: Termination Ohm Reading – read at E2 or Router/Repeater Echelon connection. White to Blue wire (not to ground) with connector plugged into controller.

0 termination = 3 Meg Ohm or higher, up to infinity. No segment should be un-terminated.

1 termination (only one end terminated) = 105 (+ 33 Ohms per 1000 feet)

2 termination (both ends terminated) = 52 (+ Resistance from the wire)

3 termination (triple terminated) = less than 52 Ohms. No Segment should be triple terminated.
