Upgrading Einstein Using the Einstein Upgrade Kit

This bulletin explains how to use the components of the CPC Upgrade Kit to upgrade a pre-1.5 version Einstein unit to the latest (post-1.5) Einstein release.

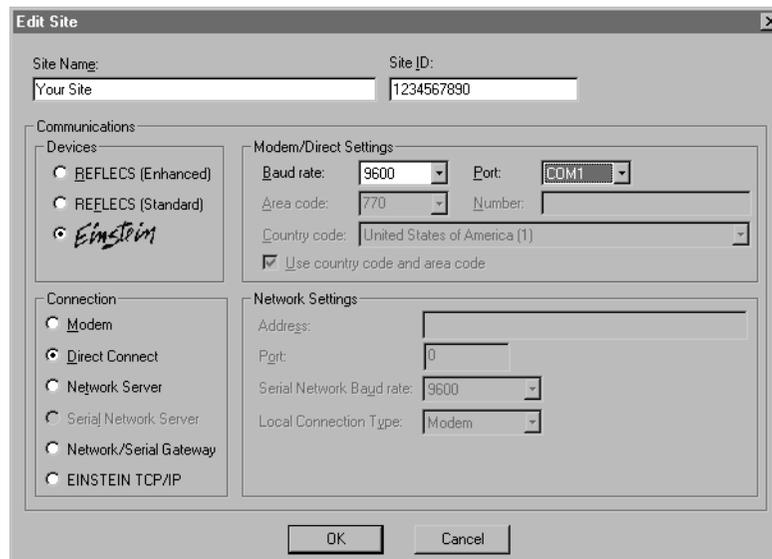
Figure 1 - Site Communications Dialog Box

1. Using the supplied direct connection cable, connect the 9-pin male end to the serial port on the left-hand side of the Einstein box. Connect the other end to a serial port on your laptop or desktop PC.
2. Follow the instructions in the UltraSite32 User's Guide for creating a directory and creating a site. In the "site communications" box, set the Device type to "Einstein" and the Connection type to "Direct Connect." In the Modem/Direct Settings box, set the Baud Rate to 9600, and from the "Port" pull-down menu, choose the COM port to which the direct connect cable is attached. (See Figure 1).

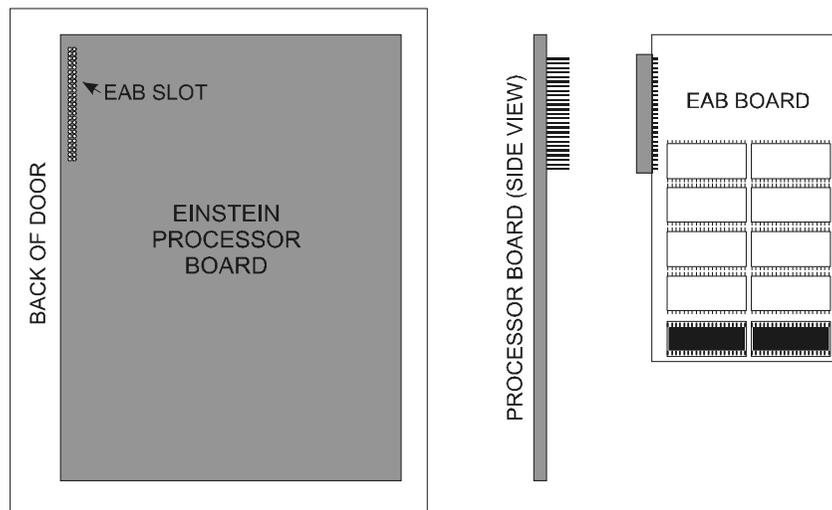
The EAB slot on the Einstein processor board is a 50-pin (25x2) port located on the upper left corner of the Einstein processor board (see Figure 2). **Carefully** plug the EAB board into the EAB slot, with the chips on the board facing away from the processor board.

Make sure all pins are correctly aligned with the port on the EAB board before applying pressure, or else one or more pins might bend or break.

Figure 2 - Plugging the EAB Board into the EAB Slot
